7th European Congress on REgional GEOscientific Cartography and Information Systems (EUREGEO)

12th to 15th June, 2012
Bologna, Italy.

Landslide monitoring in urban area; reactivating old inclinometers in Roma.

Marco Amanti*
Vittorio Chiessi*
Luca Maria Puzzilli*

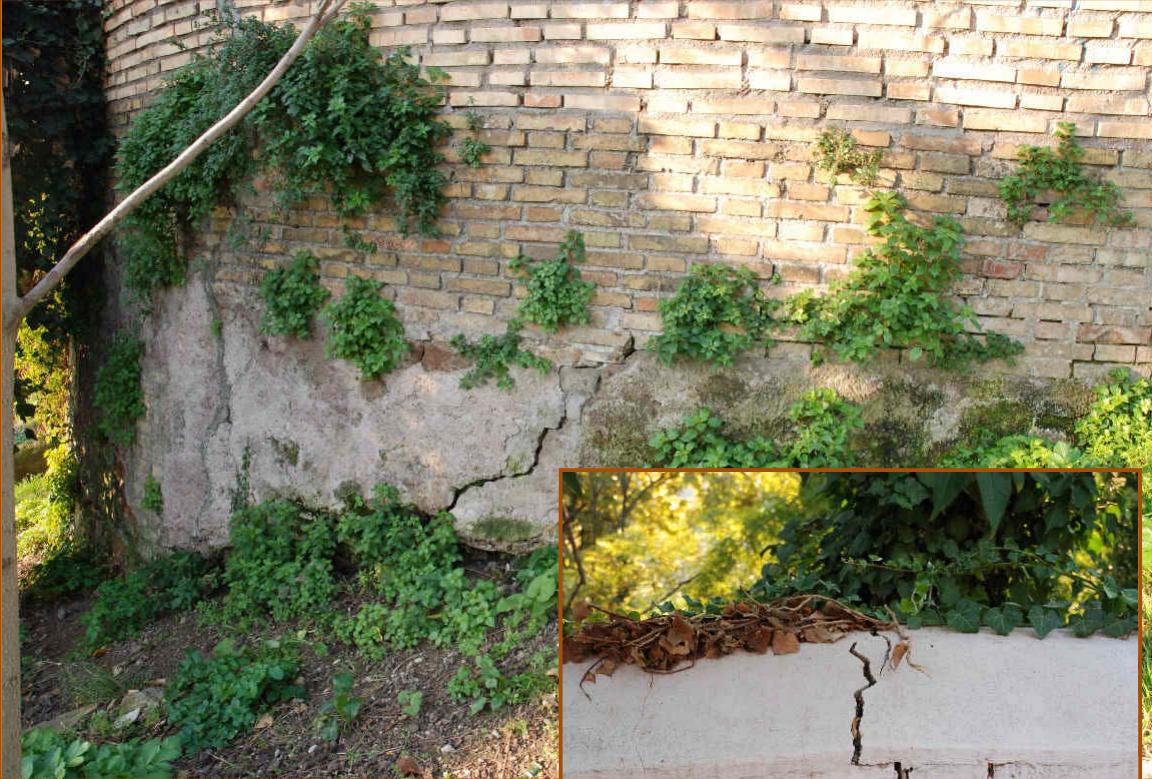
2000 - today

**Cracks in the walls,
in the middle of the
slope.**

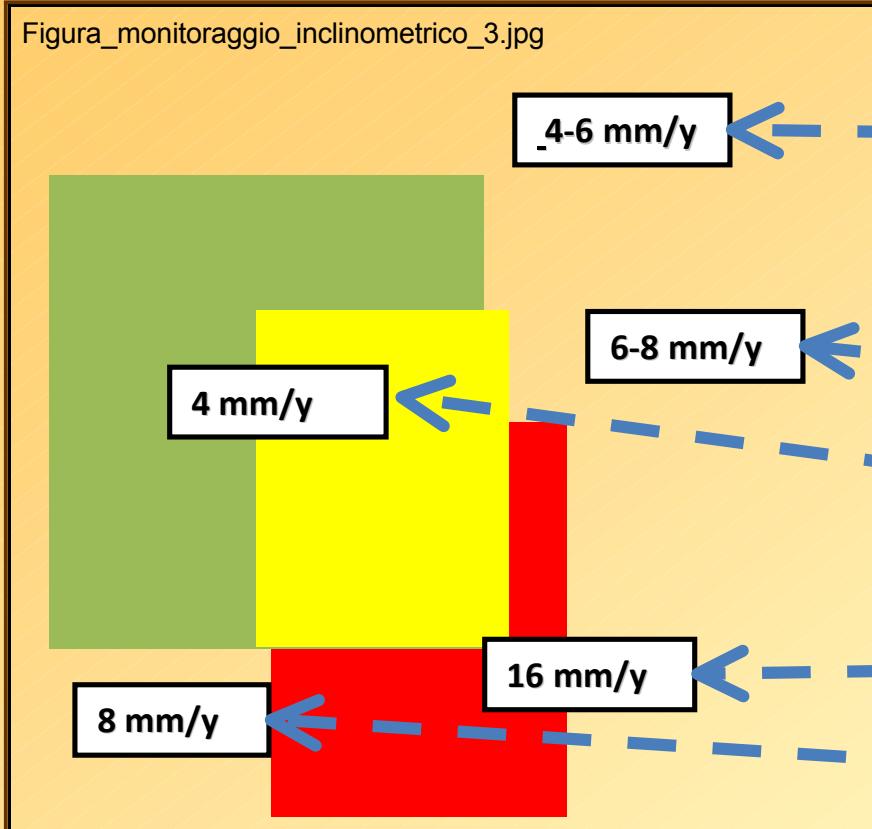
Preliminary zoning deriving from GEOTER
inclinometer monitoring (1990 – 1year)

Superimposing superficial displacements information with horizontal in depth displacement suggested by GEOTER (1990) gives a more complete information about old displacement rate along the slope.

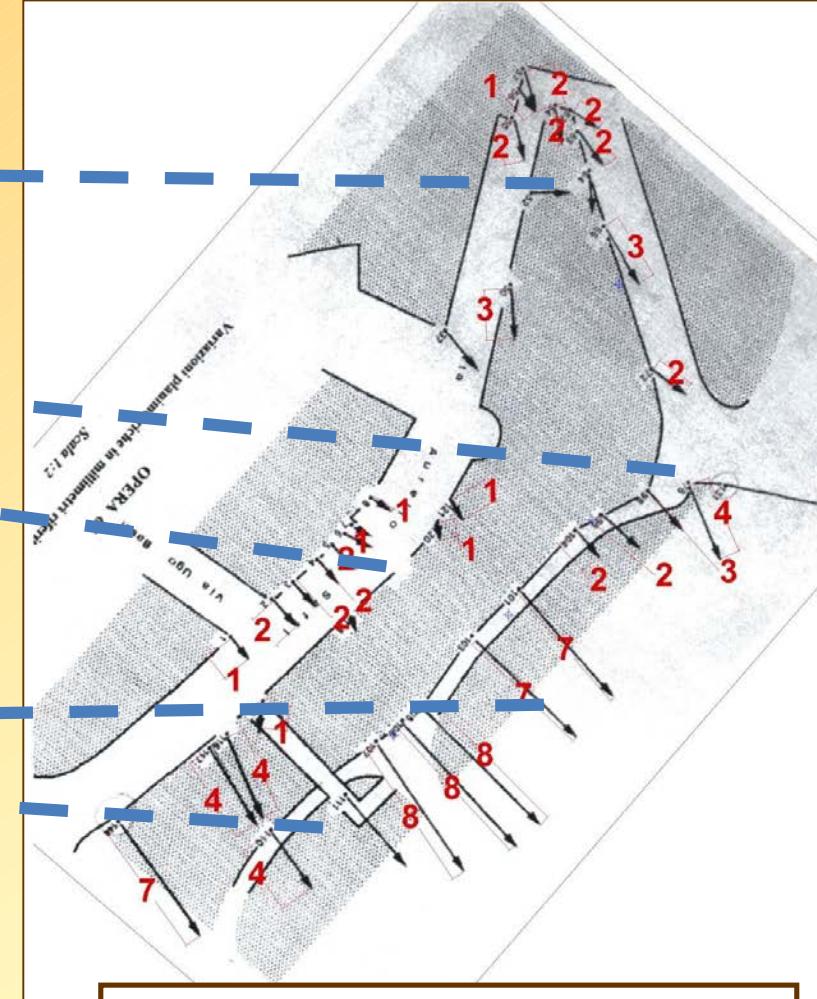
S.A.G.-C.I.M. 1990 - 1995
Total superficial displacements from
geodetic measurements (in cm)

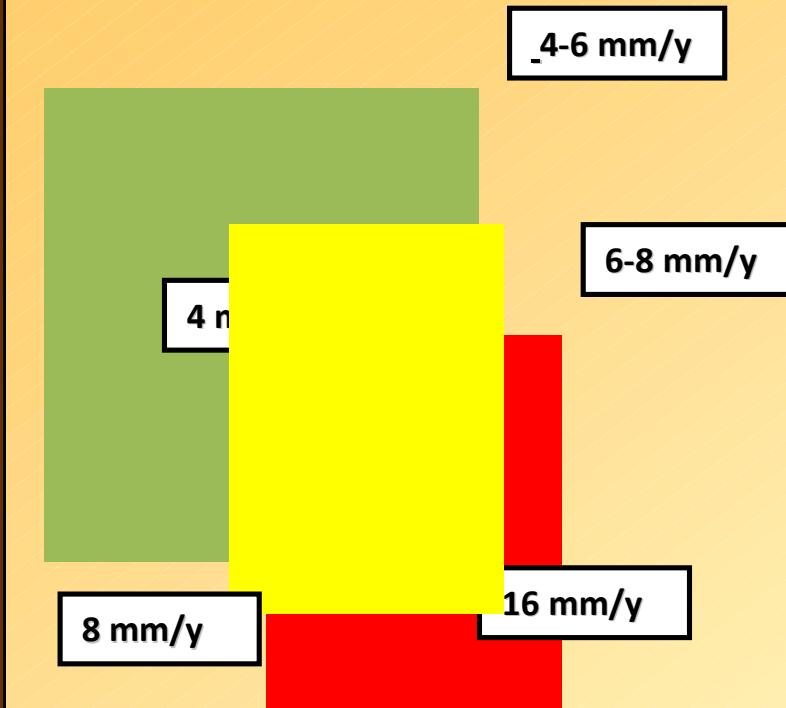
Preliminary zoning GEOTER inclinometer monitoring and S.A.G.-C.I.M surface geodetic (1990 – 1995)

5 mm/y

5-10 mm/y

10-22 mm/y

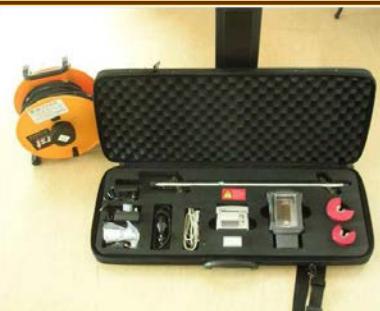
Our instrument consisting in a digital inclinometer system from RST Instruments with a data resolution of 0.005 mm / 500mm.

SPECIFICATIONS		
INCLINOMETER	METRIC SYSTEM	IMPERIAL SYSTEM
Wheelbase	0.5 m	24 in
Probe diameter	25.4 mm	1.00 in
Probe length (including connector)	710 mm	28.0 in
Probe weight	1.4 kg	3.0 lbs
Probe material	Stainless steel	Stainless steel
Full-scale range (other ranges available)	30 degrees	30 degrees
Data resolution	0.005 mm per 500 mm	0.00002 ft per 2 ft
Memory	>1,000,000 readings	>1,000,000 readings
Repeatability	±0.002°	±0.002°
System Accuracy	±2 mm per 25 m	±0.1 in. per 100 ft
Axis alignment	Digitally nulled	Digitally nulled
Temperature rating	-40 to +70°C	-40 to +158°F
Sensor Type	MEMS Accelerometer, Biaxial

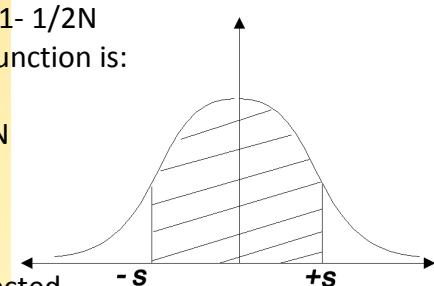
and if $|t_{susp}| > s$

the measure could be rejected

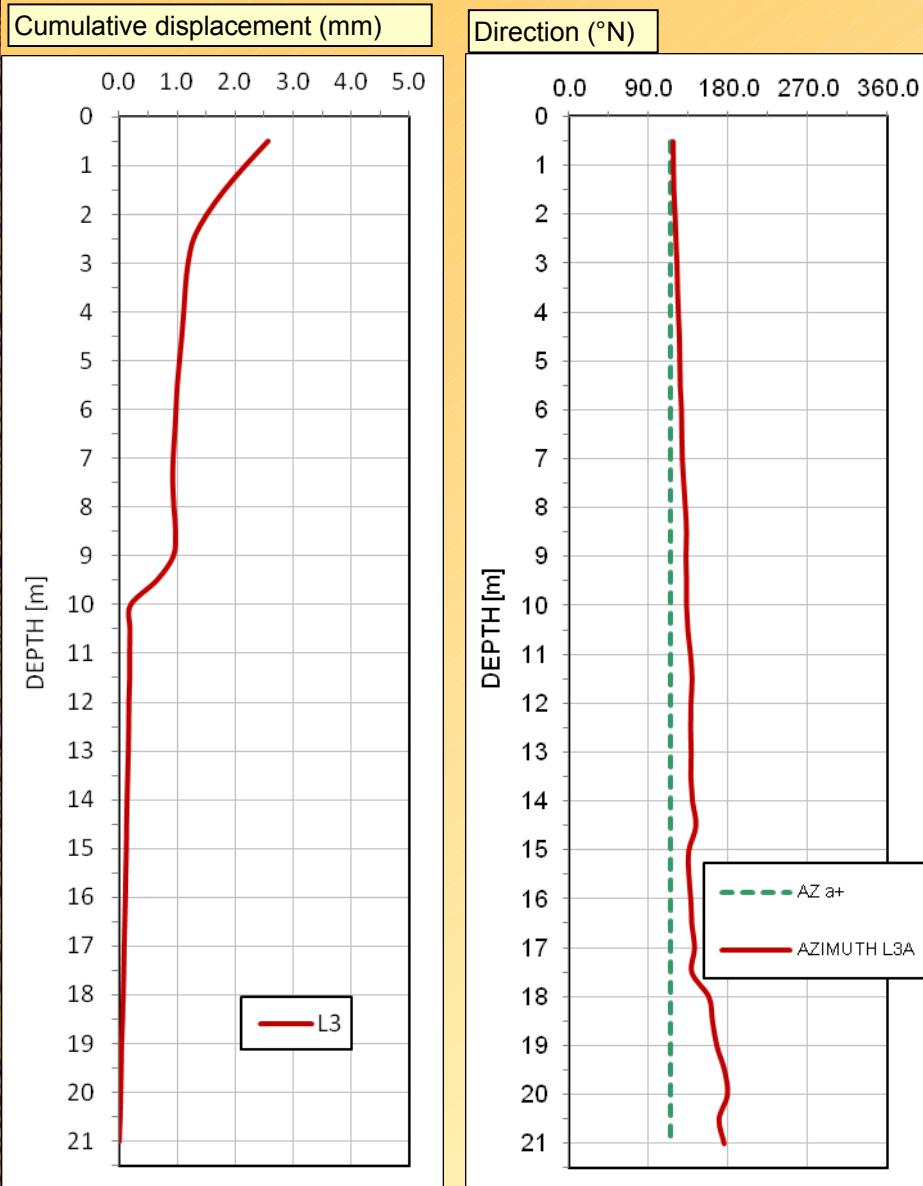
After about six months the integrated cumulative displacement for this inclinometer is about 2.6 mm that represents half of the expected value for 1 year.

The curve is clearly affected by a very **small systematic error** but it's necessary to investigate the reliability of the displacement in the depth range **9-10 mt** and in the depth range **0.5-5 m**

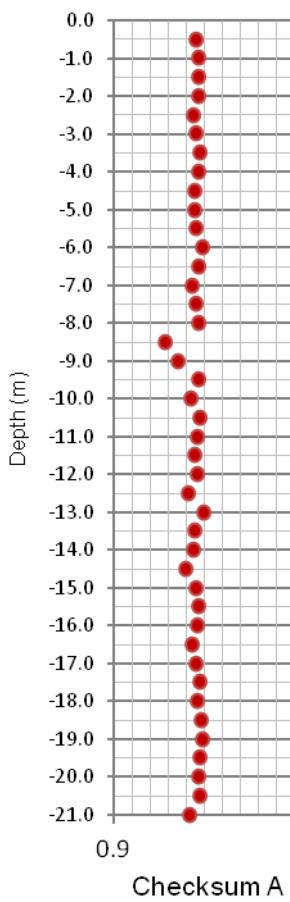
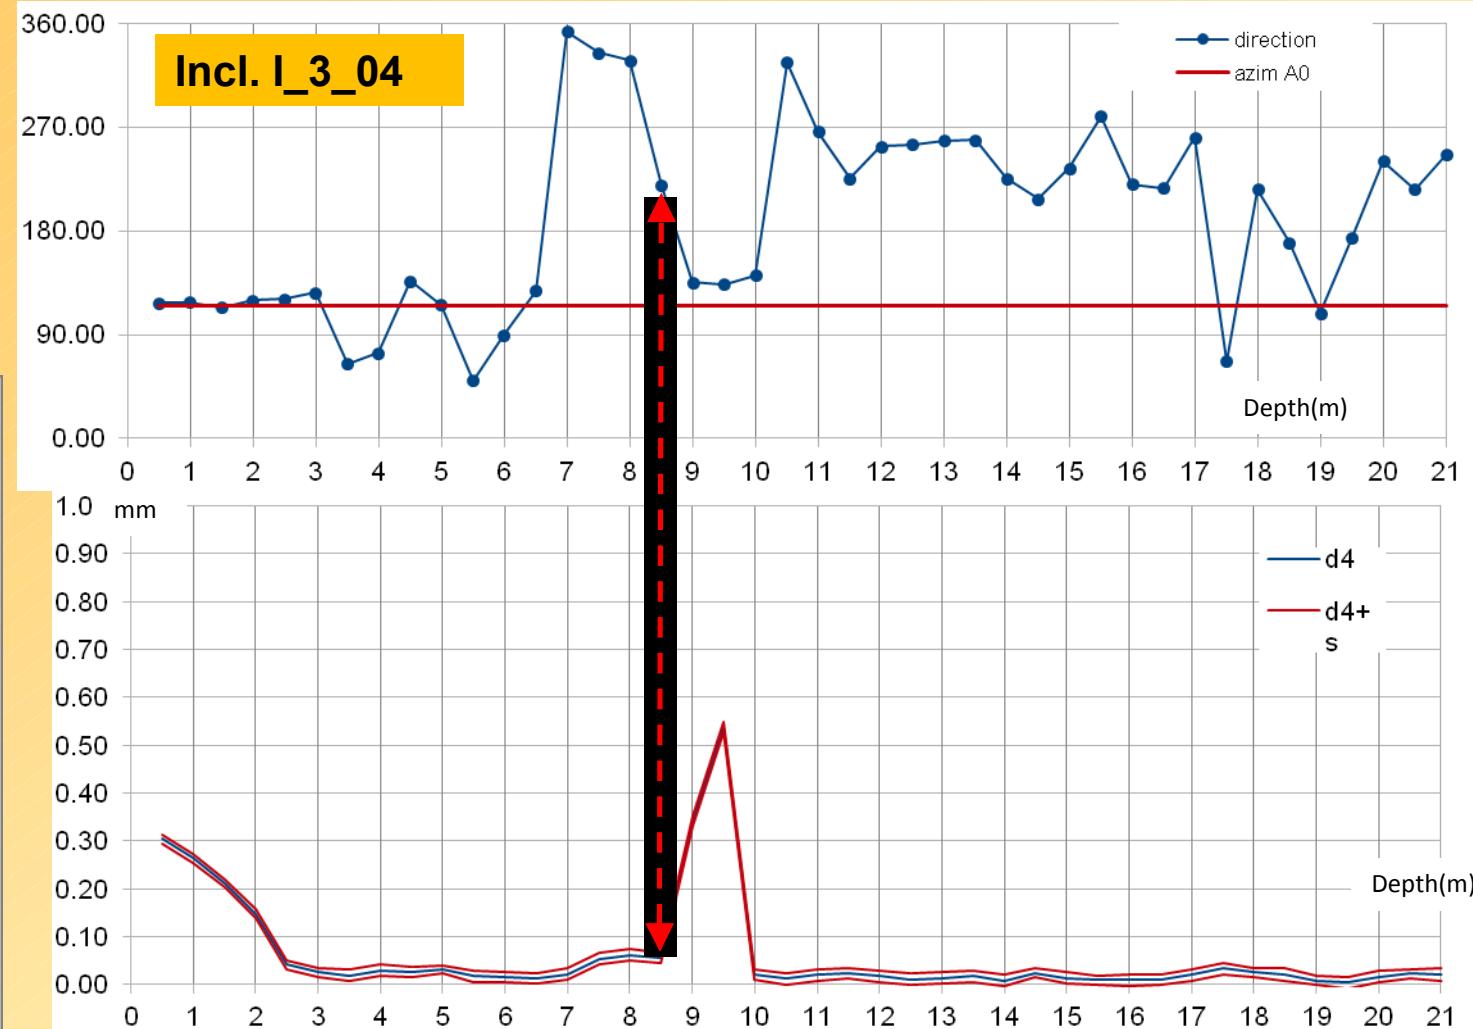
Integrated displacement and direction at each depth (after 165 days)

Checksum value at depth of 8.5 is suspected to contain a **gross error**, value was rejected applying a statistical analysis (chauvenet criteria).
 The direction of integrated displacement in the **depth range 9-10 m** is not so far from A0.
 The depth range of interest for this inclinometer is now from 10 mt up to surface.

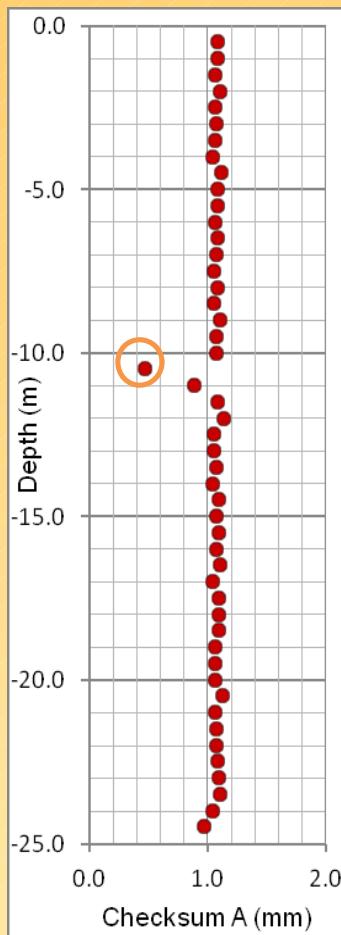
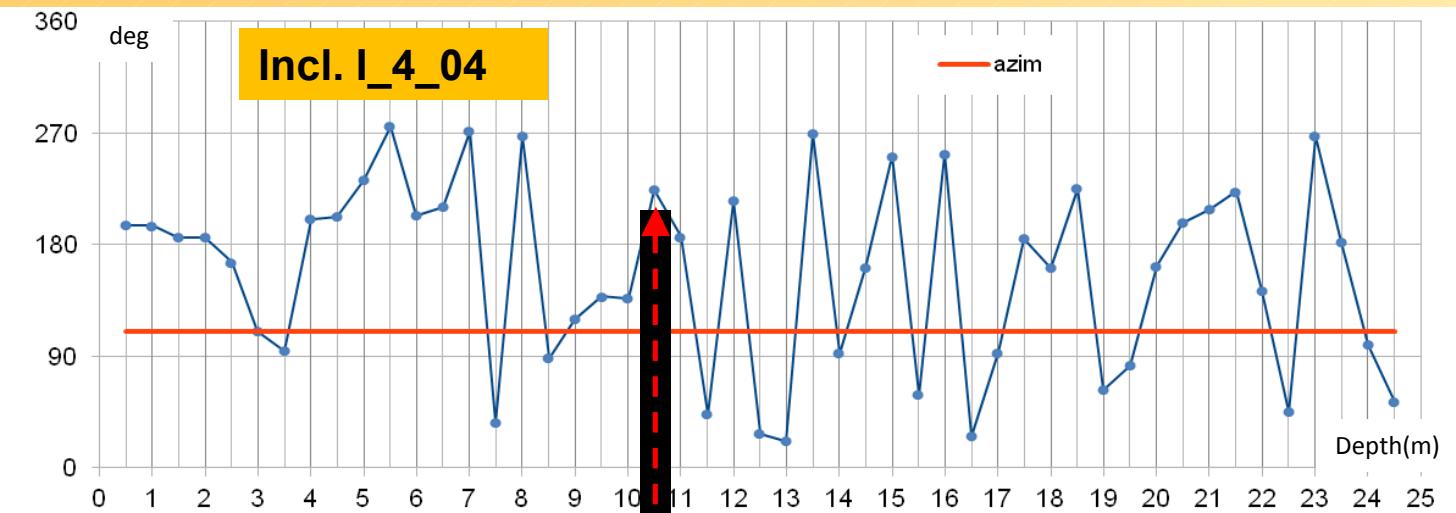
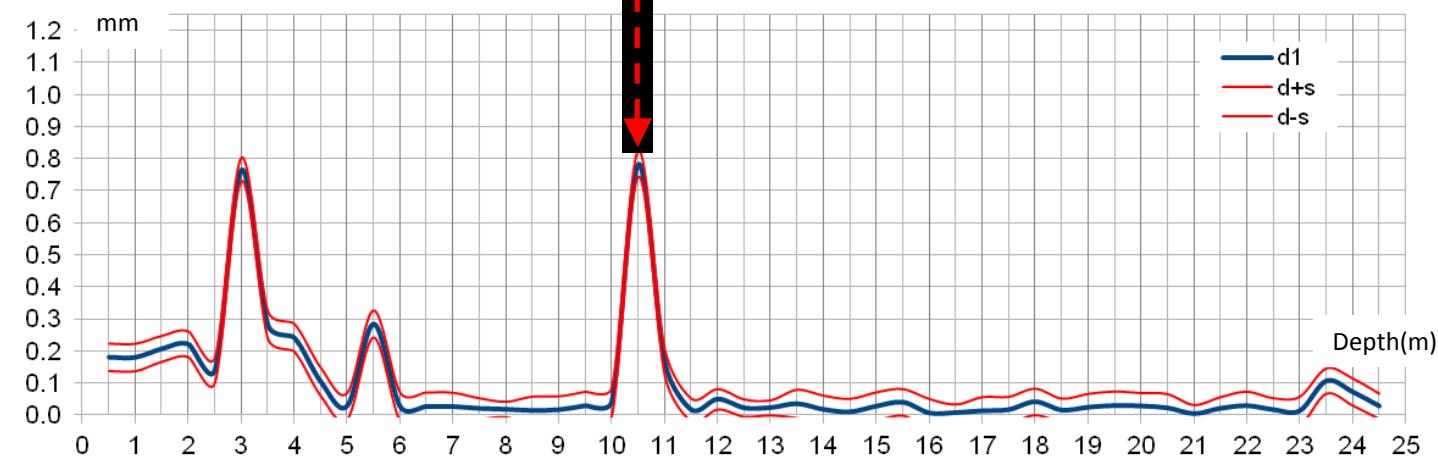
Integrated displacement and direction at each depth (after 30 days)

Checksum value at depth of 10.5 m is suspected to contain a gross error, value was in fact rejected applying a statistical analysis (chauvenet criteria).

The direction of integrated displacement for depth of 10.5 m is far from the direction A0 (in red).
