REMOTE SENSING OF LAND USE CHANGES AND LANDSLIDING FROM 1955 TO 2006 IN ROCCHETTA S. ANTONIO, THE DAUNIA APENNINES

Domenico Casarano, Marina Dipalma Lagreca, Caterina Lamanna,
Janusz Wasowski

7° EUREGEO,
Bologna, June, 14, 2012

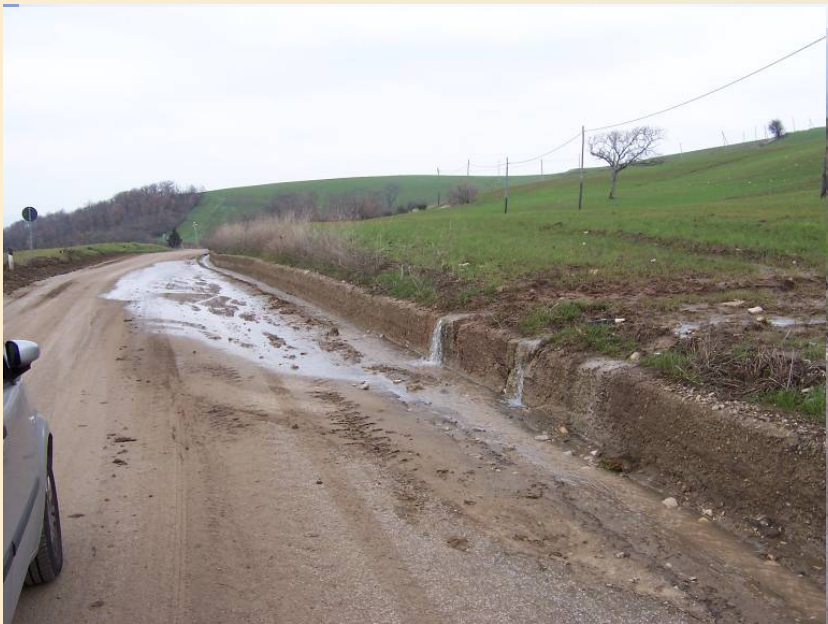
Landsliding along the SP99bis road

30 landslides interesting the road :

- Intensive crops on the slopes adjacent to the road
- Lesions to the continuity of the original surface of the side
- Changing the natural hydrological regime: 99 water inflow and outflow points were mapped along the road after an intense rainfall event
- Variation of stress on the slope
